2002 Annual Compliance Report Falls City, Texas, Disposal Site

Compliance Summary

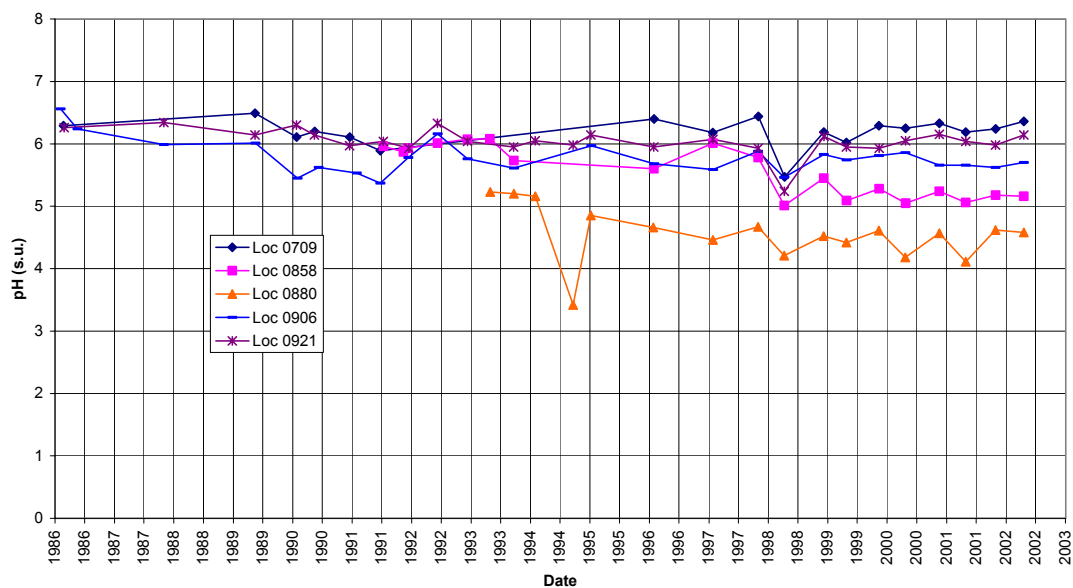
Figure 5-3. Plots of Ground Water pH at Cell Performance Monitor Well Locations at the Falls City, Texas, Disposal Site

The Long-Term Surveillance Plan identifies pH as the indicator parameter for cell performance monitoring on the basis of tailings pore-fluid chemistry. However, legacy plumes typified by low pH exist beneath the cell in a ground water mound created by infiltration from historical tailings impoundments and mill effluent discharges. These plumes would be expected to spread outward as the ground water seeks an equilibrium level; however, buffering mechanisms caused by interaction of low pH waters and formation materials are expected to limit plume extent. The pH of the ground water samples collected in 2001 and 2002 was essentially unchanged and consistent with previous results for all wells (Figure 5–3).

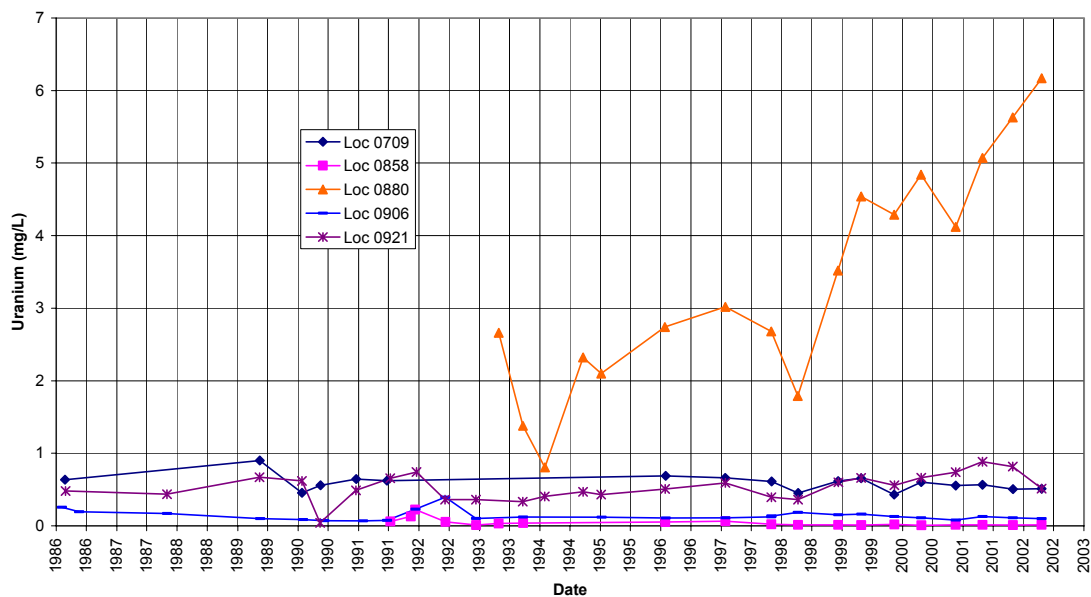
Figure 5-4. Time-Concentration Plots of Uranium in Ground Water at Cell Performance Monitor Well Locations at the Falls City, Texas, Disposal Site

Analytical results from 2002 are consistent with previous results and what would be expected of ground water contaminated by uranium mineralization. Of the 10 analytes, concentrations of arsenic, cadmium, selenium, and uranium, and activities of radium and gross alpha, continue to exceed their respective standards in several wells. Uranium concentrations, though near or below the standard in most wells, continue to increase well above the standard in monitor well 0880 (Figure 5–4). This increase in concentration may be an indication of a legacy plume spreading outward as expected.

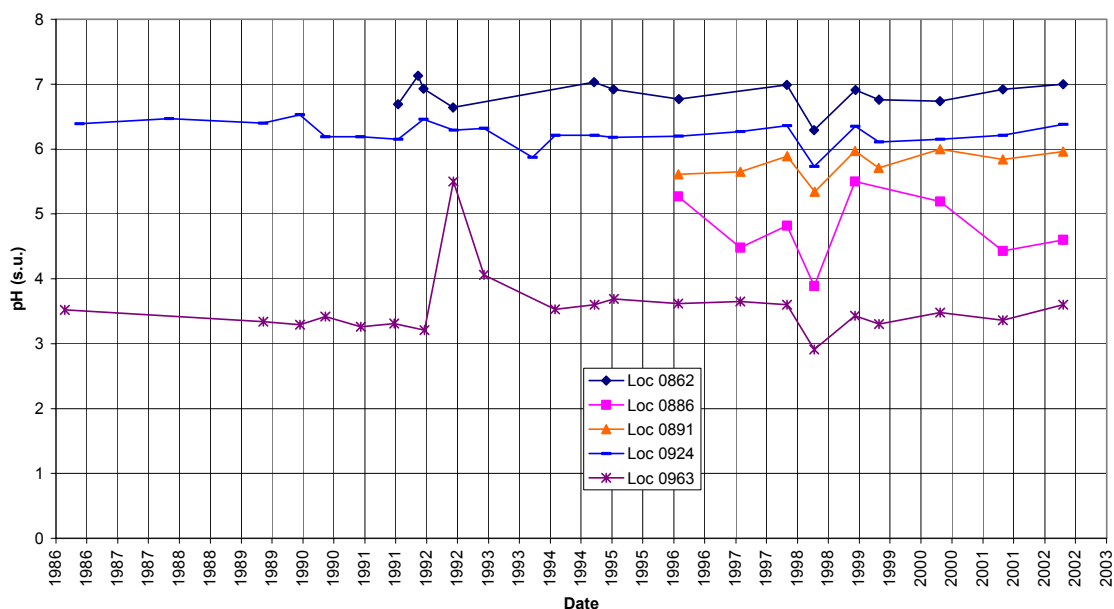
Figure 5–5. Plots of Ground Water pH at Compliance Monitor Well Locations at the Falls City, Texas, Disposal Site

The compliance monitoring network consists of five wells (0862, 0886, 0891, 0924, and 0963). Sample locations were selected on the basis of ground water flow direction from the two plumes. The wells are sampled annually and analyzed for 33 analytes, of which 10 have a standard specified in Table 1 to Subpart A of 40 CFR 192 (Table 5–2). Concentrations of cadmium, selenium, uranium, and activities of radium and gross alpha continue to exceed their respective standards in several wells. Analyte concentrations at most locations remained essentially constant. Plots of pH measurements and uranium concentrations are shown on Figures 5–5 and 5–6.

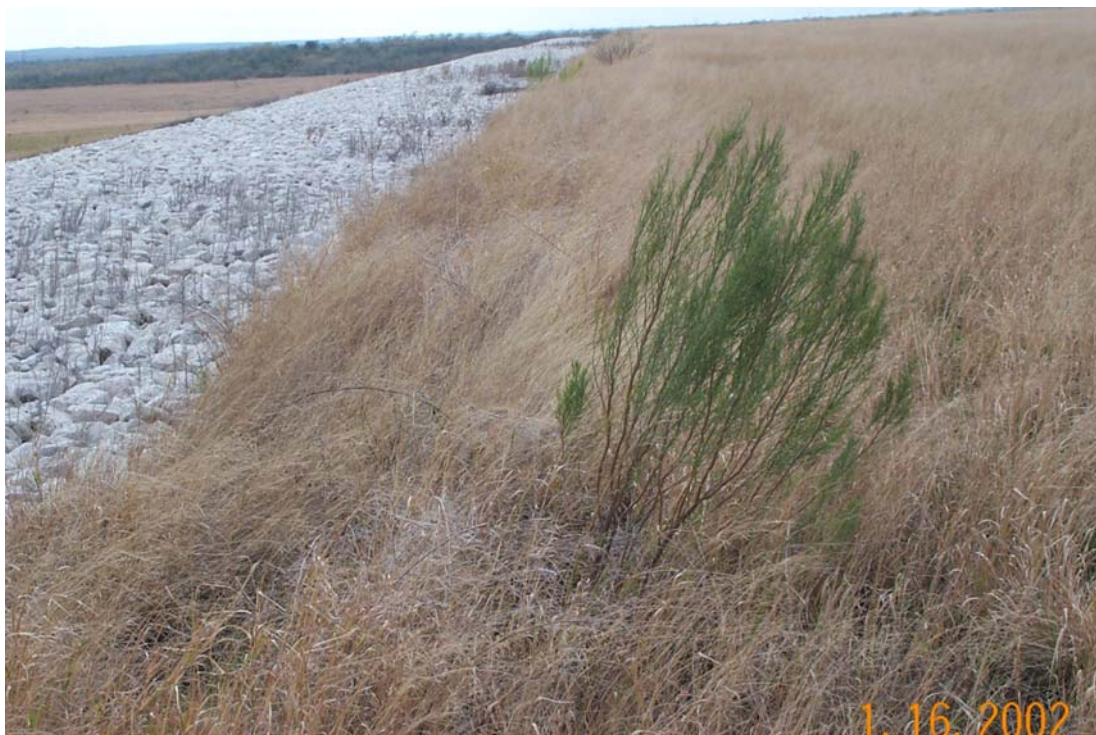
5A **Top and Side Slopes of the Disposal Cell**—The top of the disposal cell is covered with well-established coastal Bermuda grass and was in excellent condition. The grass is cut and baled by a local farmer. There are no trees or woody shrubs on top of the disposal cell; grass cutting appears to be an effective control of these plants. Some woody species have established along the edge of the transition zone (PL-1) where the grass is not cut because of proximity to the riprap. These shrubs were cut and herbicide was applied to the stumps.

PL-1. Woody vegetation on southeast edge of cell top.

A perimeter sign was resecured at its proper position on its signpost. Woody plants along the transition zone between the cell top and the side slopes were cut down and their stalks were treated with herbicide. As an annual maintenance item, grass on the cell top and between the cell and the perimeter fence was cut and baled by a local farmer.

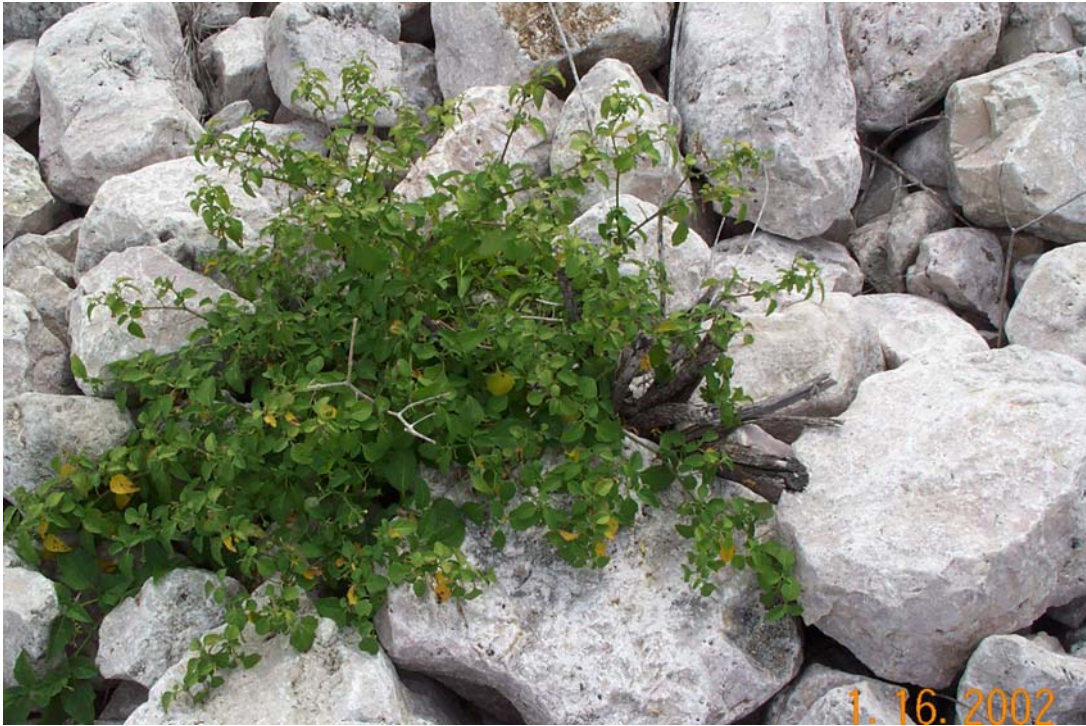
Small scattered trees and bushes that had established on the side slopes were mostly absent. Inspectors sprayed the plants with herbicide in previous years and a local farmer was contracted to eradicate the perennial plants. Greasewood and similar species are concerns because they are deep-rooted. Most vegetation was dead including annual plants and most woody species; however, new growth on some previously treated plants was observed (PL-2). Vegetation control will continue on the side slopes.

PL-2. New growth on previously treated vegetation.
